32-BIT MICROCONTROLLER STARTERKIT  
**SK-FM3-100PMC**

**FUNCTIONAL LIMITATION**

**CUSTOMER INFORMATION**

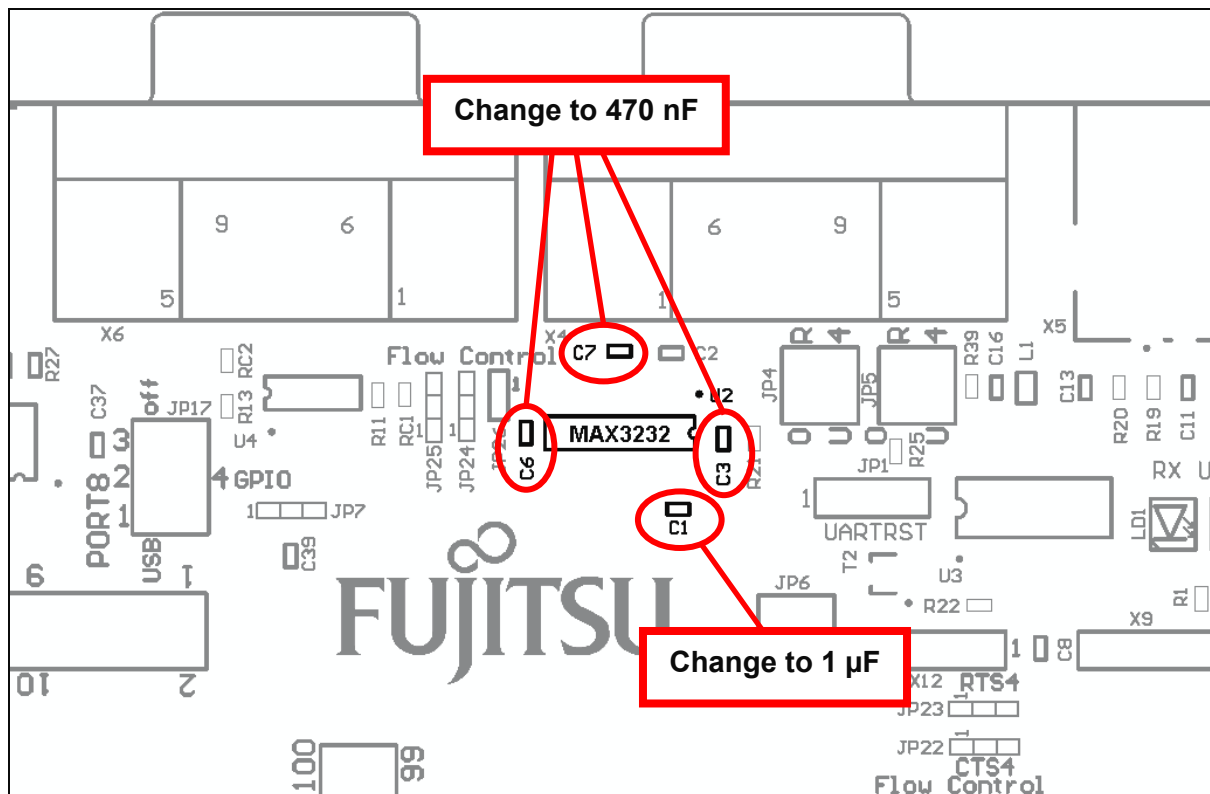
The external capacitors for the MAX3232 are too small according to MAXIM™'s specification for usage between VCC = 3.3 Volts and VCC = 5 Volts, resulting in a VCC noise ripple. This ripple influences the AVCC and AVRH analog supply and reference voltage inputs, which leads to inaccurate ADC conversion results.

The problem is caused by schematic components choice error.

The capacitors are located on the board shown in the illustration below:

For ADC usage the following capacitors have to be replaced with new values:

Capacitor reference	Old value	New corrected value
C1	100 nF	1 $\mu$ F
C3	100 nF	470 nF
C6	100 nF	470 nF
C7	100 nF	470 nF
