Heavy Ion, Single Event Effects (SEE) Final Report for Cypress Semiconductor CYRS16B256 Serial NOR Flash 256-Mbit

Date: 27 Oct 2020

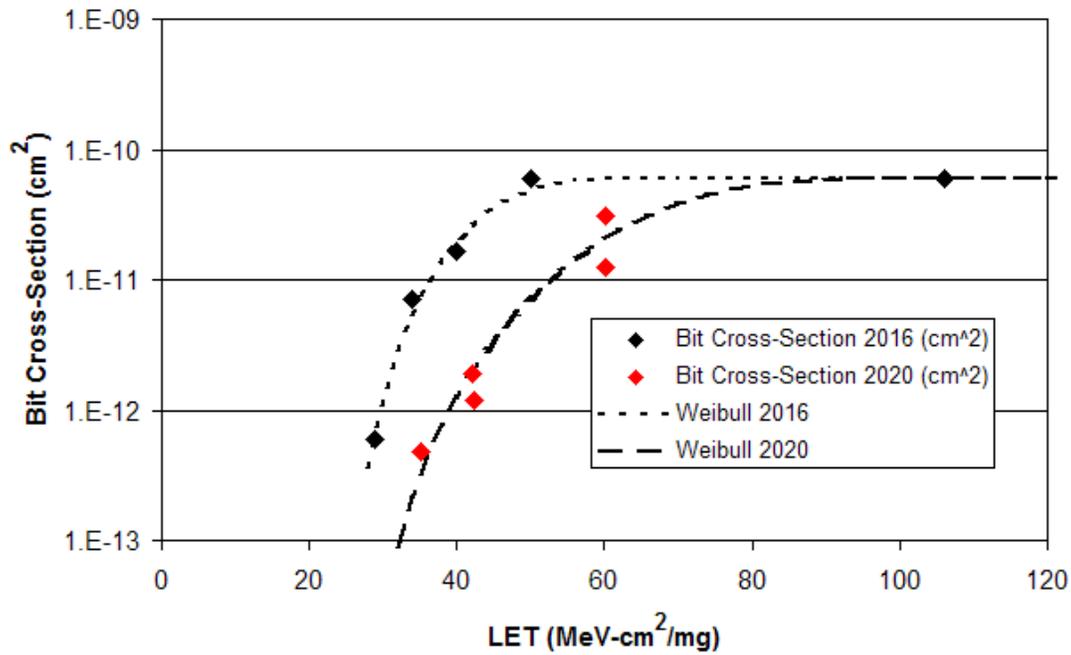
Figure 8. Bit Upset Cross-Section, 2016 vs 2020

This graph clearly shows that bit upset cross-sections in radiation tolerant parts were consistently lower than for the commercial parts. These results were as expected because the radiation tolerant version of the parts use different ERASE/WRITE parameters compared to the standard commercial parts. Figure 9 shows the distribution of threshold voltages (Vt's) over the population of bits tested.

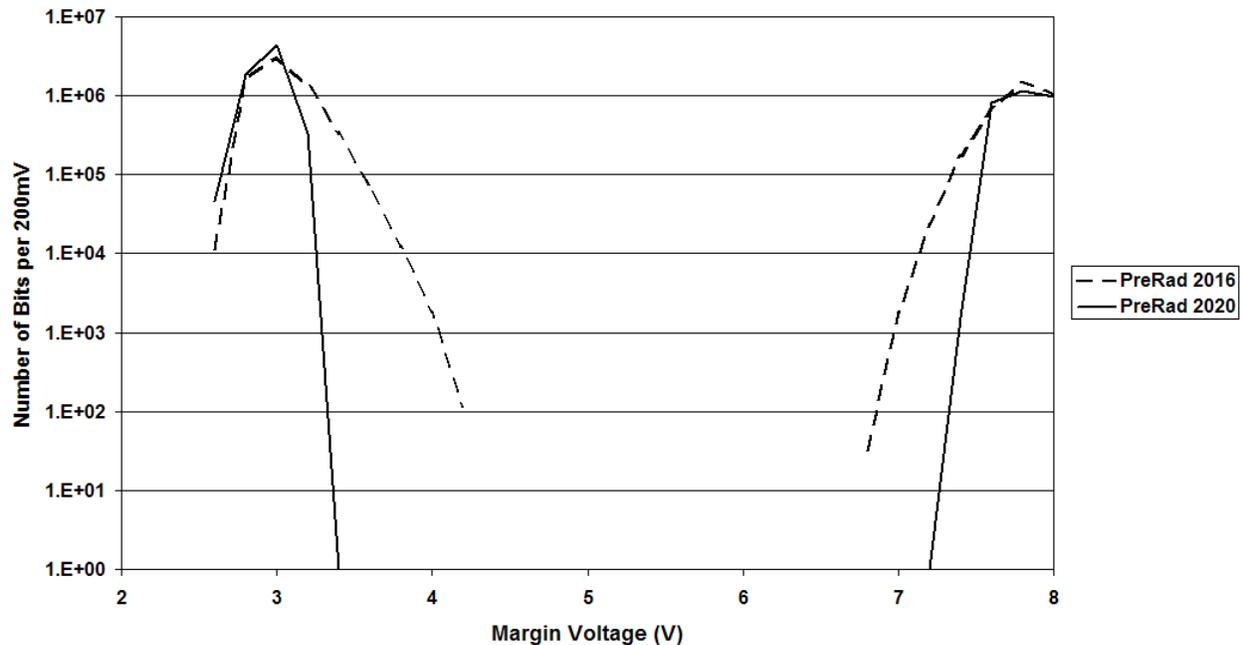
Figure 9. Pre-Radiation Vt Distributions, 2016 vs 2020

In this figure the population of ERASED bits is in the left half of the plot and programmed bits in the right half. Note that the distribution of V_t 's is much more tightly grouped in the radiation tolerant version of the parts and that the separation between the lower portions of the ERASED vs PROGRAMMED bits is much further apart. Since the V_t of memory bits struck by heavy ions is shifted towards the center of the graph it is reasonable to expect fewer bits to be shifted sufficiently to change their READ state if the pre-radiation populations are further apart.

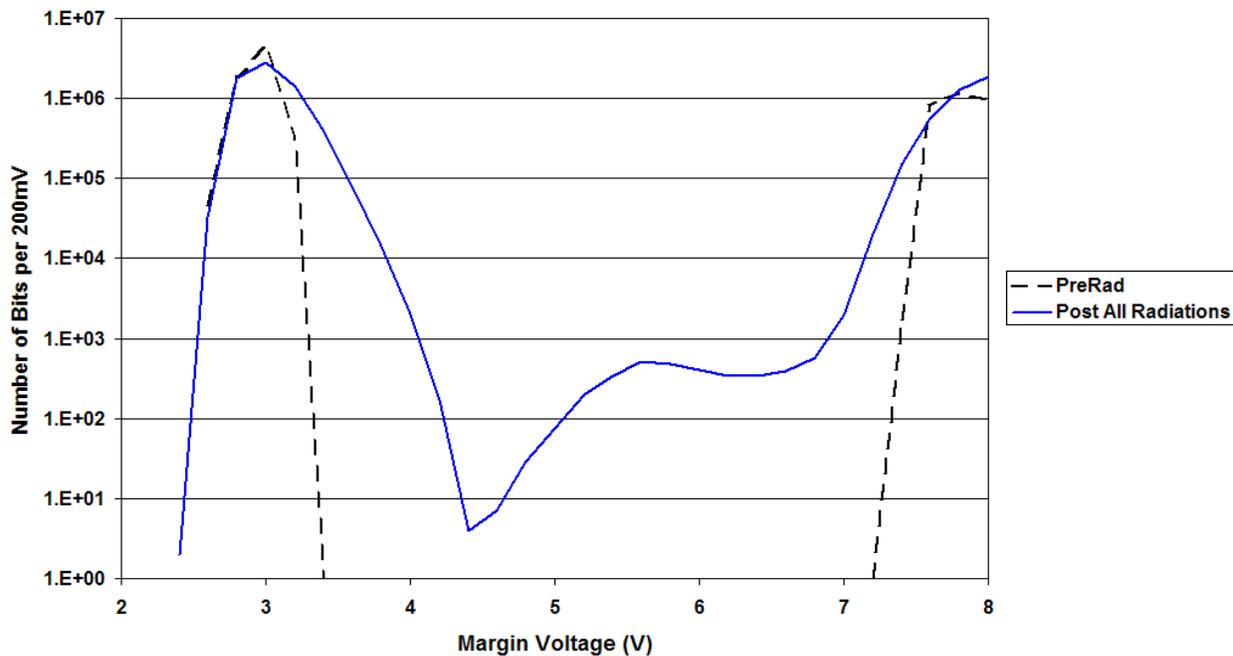
Figure 17. Vt Distribution in SN105 after all Irradiations

No exact conclusions can be drawn from this plot but it is obvious that the distribution of ERASED and PROGRAMMED bits spread out. Also, the “bump” in the distribution just “to the left” of programmed bits is the result of heavy ion strikes on memory cells.

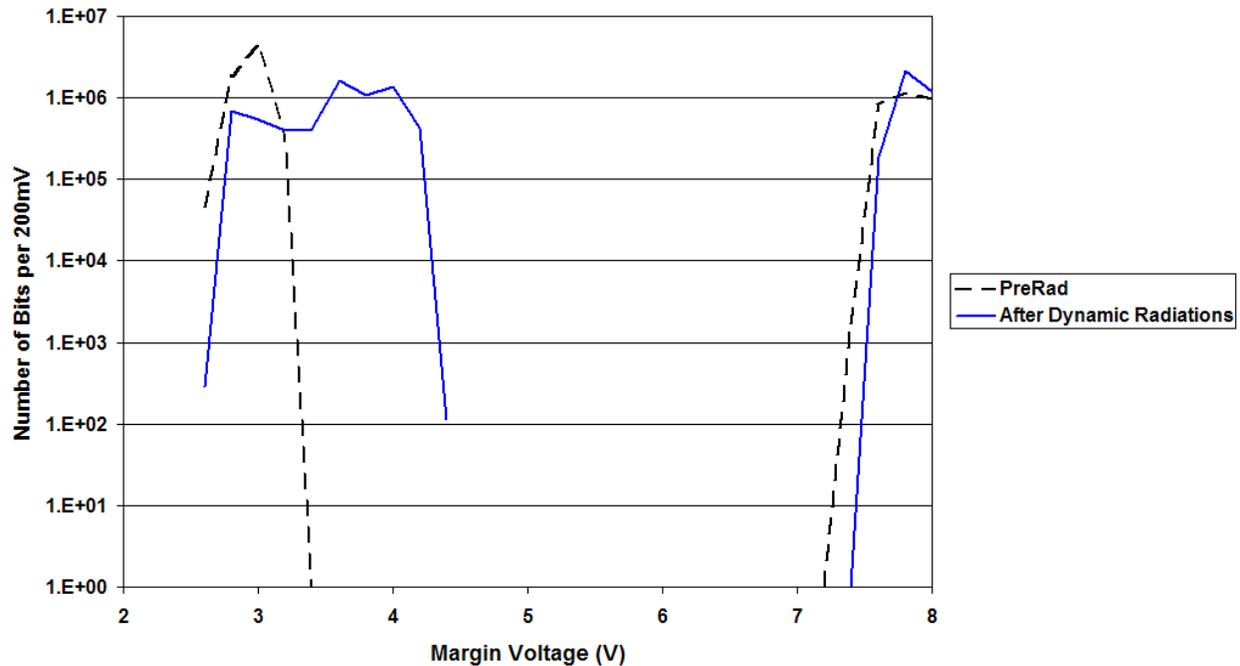
Figure 18. V_t Distribution in SN105 after all Dynamic Radiations

Vt distribution in the portion of the memory that was used for dynamic ERASE/WRITE testing was significantly different. Figure 18 shows the Vt distribution in this portion of memory for SN105. Note that the distribution of programmed bits was restored to pre-radiation values whereas the distribution of erased bits became much more widely spread. It is suspected that the ERASE operation in these parts is not applied to memory cells that read as erased. Thus, cells

with V_t 's below some value will never be erased. The only way to reset the original distribution would be to first program all memory bits and then erase them.
