FR60 Family, ISR Double Execution

This application note gives some information about the behaviour of a possible Interrupt Service Routine (ISR) Double Execution.

Document Title: AN205203 - FR60 Family, ISR Double Execution

Document Number: 002-05203

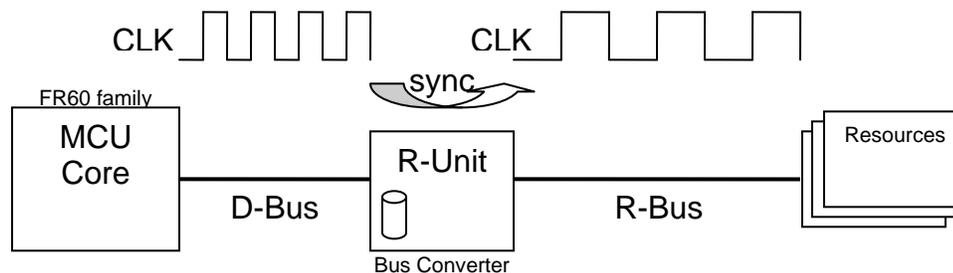
Figure 1. D- + R-Bus Clock Domains

The FR60 family possesses an additionally inserted write buffers for access to the generally slower clocked R-Bus, for resources like UART's and TIMER's, and one for all CAN resource.

This write buffers give the MCU the possibility not to wait while the R-Unit or CAN syncs between CLKB and the slower Resource or CAN clock for clock ratios below or equal to 1!

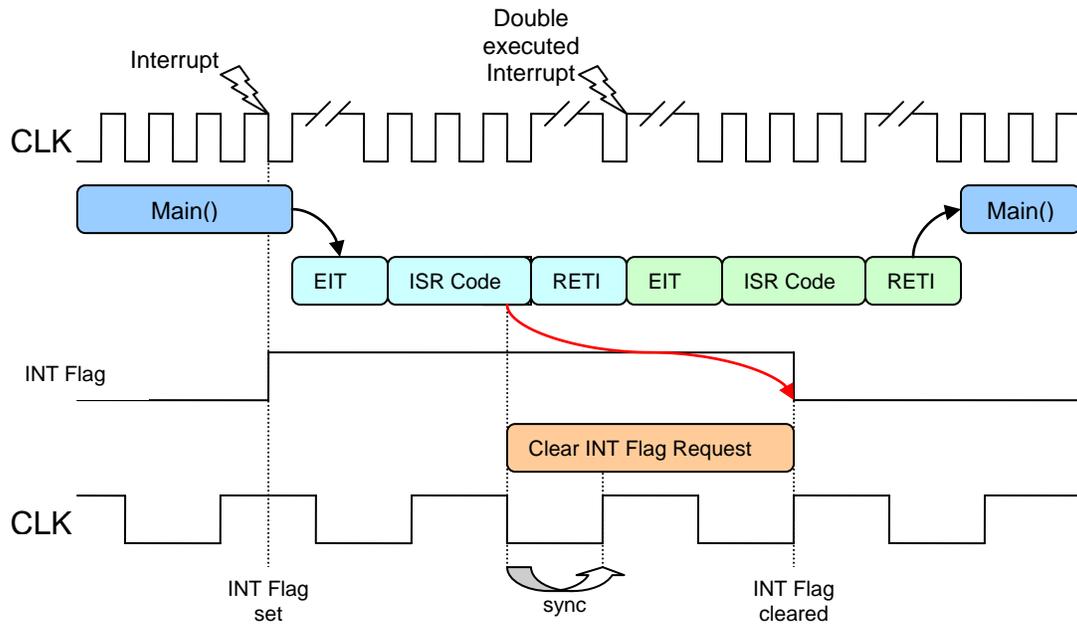
Figure 2. Double Executed Resource Interrupt Service Routine

This performance feature spawns the possible behaviour, for $\frac{CLKB}{CLKP}$ or $\frac{CLKB}{CANCLK}$ ratios lower or equal to 1, that an interrupt flag clear is not completed before the MCU core has finished the exit (RETI) from the interrupt service routine. This pushes the MCU immediately back into the interrupt service routine because the interrupt flag is still active.

This condition only comes up if there is no further read access to any Resource or any CAN resource after clearing the interrupt flag within the interrupt service routine.

The Resource interrupt service routine shown in the figure below inhibits the double execution by adding the macro call RB_SYNC to the end of the interrupt service routine. This forces an additional read access to the Resource memory space which waits until the interrupt clear instruction on the respective Resource register is completed and the write buffer is empty.
